PG-PLUS

INTEGRATED CENTRAL OFFICE LINE UNIT

Model	List Number	Part Number	CLEI Code
PLL-725	1	150-1625-01	S9L1AG0AAA

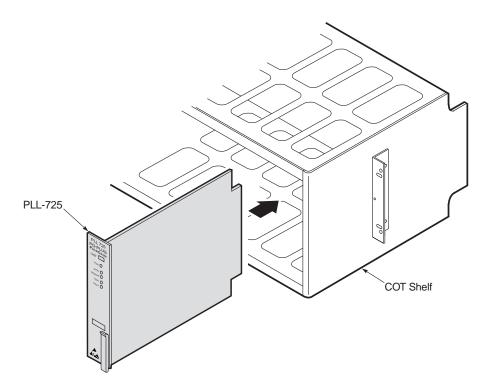
Figure 3. Installing the ICOLU into a COTS

- 1 Open the retaining latch on the front of the ICOLU.
- 2 Insert the ICOLU into the card guides in a vacant slot in the COTS that corresponds to the location of the wiring from the CO switch (see Figure 3). Refer to the cabling tables provided in the COTS documentation for slot and Telco cabling assignment.
- 3 Engage the retaining latch to hold the card in place.

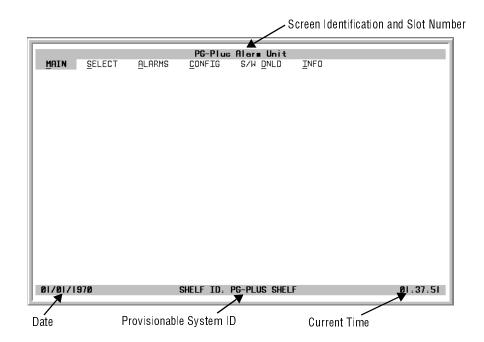
PAU OR PMU MAIN SCREEN

The first screen displays with the COTS Main menu bar. The screens are identified by the COTS slot number at the top of each screen. The provisionable System ID string displays at the bottom center, the date displays at the lower left of the screen and the time in military format displays at the lower right of the screen.

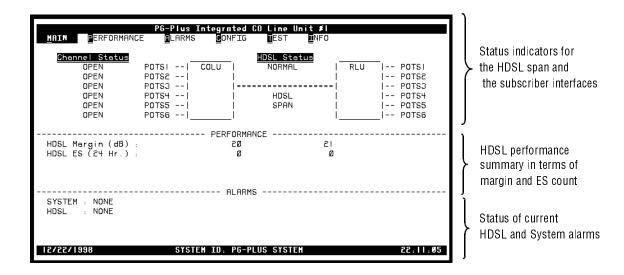
This screen details the performance condition of the ICOLU and RT.

1 Select *Main* from the menu bar and press **ENTER** to view the ICOLU Summary screen.

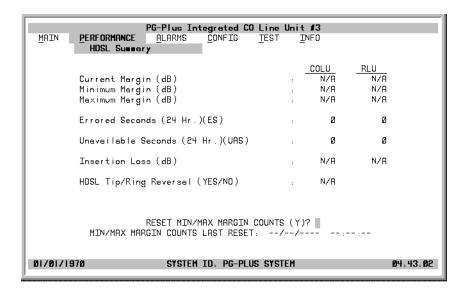
HDSL Summary Screen

This screen depicts an HDSL performance summary in terms of the margin and ES count.

3 You can reset the minimum and maximum margins to the current margin values for the ICOLU or RT. Type Y at the Reset MIN/MAX Margin Counts prompt to reset the values. If the MAR value falls below or exceeds the value set here, then alarms are registered at the criticality level selected at the "HDSL Alarm Types Screen" on page 28 and displayed at the "ICOLU Summary Screen" on page 13.

The date and time of the last reset of the minimum and maximum margin values display at the bottom of the screen.

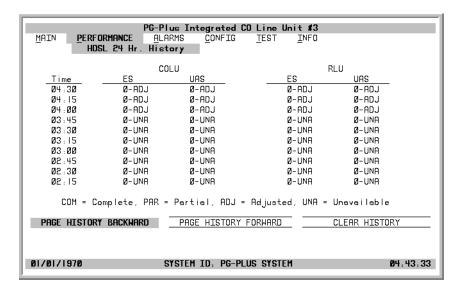
This screen shows twenty-four hours of HDSL performance history. The performance history data displayed includes ES and UAS counts, and the validity of the counts for the ICOLU and the RT.

In the Time field, the current 15-minute interval information shows the real-time updates. For example, the time interval marked 4:00 contains the information for 4:00 am to 4:15 am. The ICOLU derives the ICOLU and RT performance parameters, which have the valid field values of:

- Unavailable: The system has not run long enough to fill this register.
- Partial: Data is being collected for this register.
- Complete: Data is saved in the history register for the complete interval.
- Adjusted: The time or date has been changed on the system during the interval.
- 3 Highlight either of the paging buttons and press **ENTER** to scroll through all ninety-six 15-minute intervals.
- 4 Highlight the Clear History button and press **ENTER** if you want to clear the history.

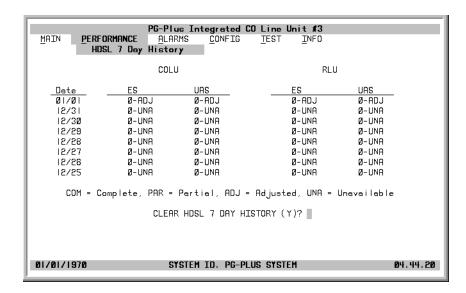
2 Scroll to the HDSL 7 Day History option and press ENTER to view the screen:

The current day performance information shows real-time updates. At midnight of every day, the current day performance information is moved into the previous day slot and the current day performance information is cleared. The ICOLU derives the performance parameters for both the ICOLU and the selected RT with the valid field values of Unavailable, Partial, Complete, and Adjusted.

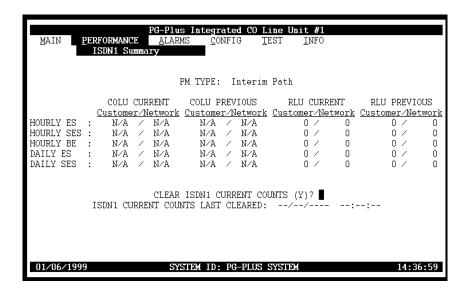
2 Scroll to the *ISDNn Summary* option and press **ENTER** to view the screen:

- ES and SES counts for the current hour, the previous hour, the current day and the previous day
- BE counts for the current hour and previous hour.

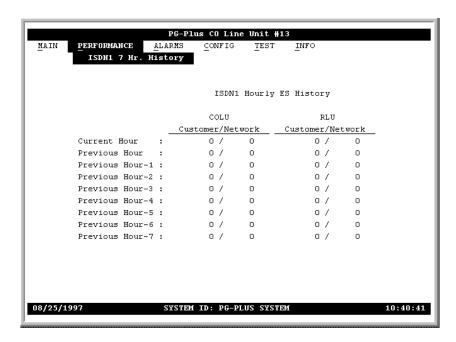
Displays the 7-hour ISDN ES history information for the COLU and the RT. The ES counts for the current hour and the previous hour are also displayed for completeness. This means that the 7-hour history begins with the hour prior to the previous hour. The PM counts are updated every 15 seconds.

Errors appearing in the Customer column indicate errors in transmission from the Network (ISDN switch) to the Customer. Errors in the Network column indicate errors in transmission from the Customer to the Network (ISDN switch).

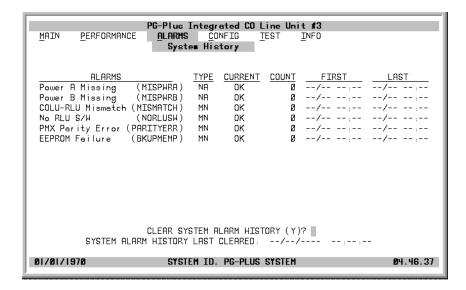
Shows the system alarm history. Abbreviations for active alarms are listed. If no alarms are present, the status word OK displays. At this screen you can view the results of the alarms set at the Configuration "System Alarm Types Screen" on page 26.

- 3 At the Clear System Alarm History prompt, type Y if you want to clear the history information. At midnight of every day, the current information is moved into the previous day slot and the current system alarm history information is cleared.
- 4 Press ESC to move up a menu level, or CTRL + R to return to the PAU/PMU Main menu

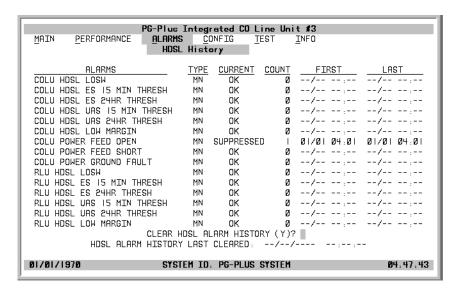
The HDSL history maintained on the ICOLU contains a count of the number of times each alarm occurred, the time and date of the first and last occurrence, the provisioned notification type, and the current status. At this screen you view the results of the alarms set at the Configuration "HDSL Alarm Types Screen" on page 28. If no alarms are present, the status word OK displays.

At this screen you see the results of the alarms types set at the Configuration "HDSL Alarm Types Screen" on page 28.

- 3 Type Y at the Clear HDSL Alarm History? prompt to clear the information. Clearing the alarm history clears the RT and the ICOLU alarm history. If there is an active alarm, then the count is set to 1 and the value in the Last date and time field is set to the First date and time field.
- 4 Press Esc to move up a menu level, or CTRL + R to return to the PAU/PMU Main menu.

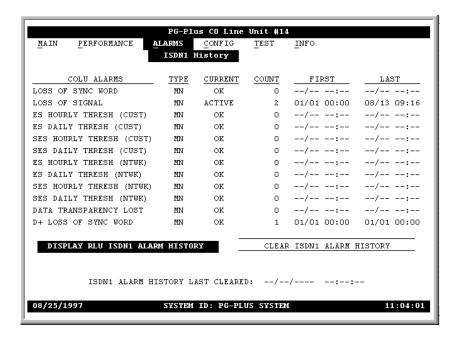
The ISDN History has two pages: the first relates to the COLU, and the second relates to the RT. The information includes the alarm name, the provisional alarm type, the current status of the alarm, the number of times the alarm was reported, the date and time of the first report alarm that of the last reported alarm. Here you see the results of the alarms set at the Configuration "ISDNn Alarm Types Screen" on page 32.

- 3 Use the Display RLU ISDN Alarm History button at the bottom to scroll through other pages of the history.
- 4 Use the Clear ISDN Alarm History button at the bottom to clear the history information..

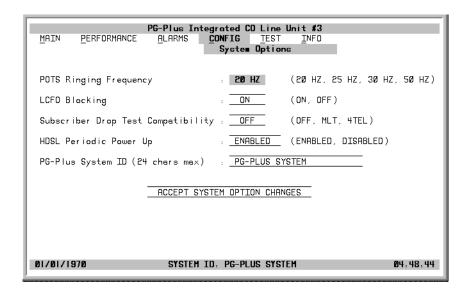
System Options Screen

System Options screen allows the provisioning of options such as ringing frequency, SDT, HDSL Periodic Power Up, and a System ID. Table 5 shows the configured system option and the factory default value.

- 3 Highlight the desired field and press SPACEBAR to toggle to the desired value, or TAB to the next option.
- 4 Press TAB to move to the Accept System Option Changes button, and press ENTER to accept the changes.
- 5 Press ESC to move up a menu level, or CTRL +R to return to the PAU/PMU Main menu

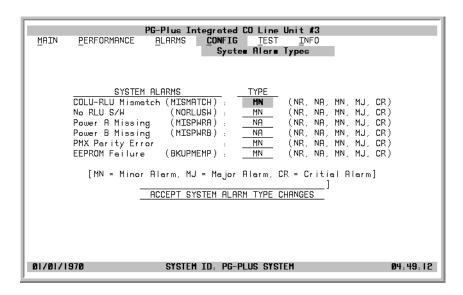
Allows the provisioning of the alarm types of all system alarms. Table 6 shows the System Alarm fields and their default settings. You can view the results of these settings from the "ICOLU Summary Screen" on page 13.

- 3 Highlight the desired field and press SPACEBAR to toggle to the desired value, or TAB to the next option.
- 4 Press TAB to move to the Accept System Alarm Type Changes button, and press ENTER to accept the changes.
- 5 Press ESC to move up a menu level, or CTRL + R to return to the PAU/PMU Main menu

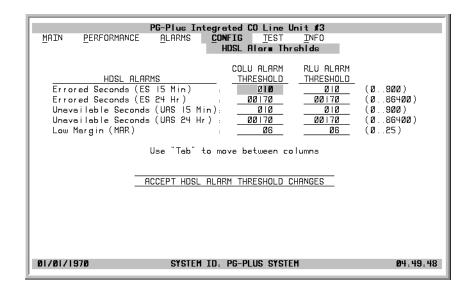
This screen is a means to provision the threshold crossing values for the 15 minute and 24-hour ES and UAS counts and low margin dB. Table 7 lists the fields of the HDSL Alarm Thresholds and the default factory values.

- 3 With the desired field highlighted, press **SPACEBAR** to toggle to the correct value for that field, then **TAB** to the next option.
- When you have completed with the changes, TAB to move to the Accept HDSL Alarm Threshold Changes button and press ENTER to accept the changes.
- 5 Press ESC to move up a menu level, or CTRL +R to return to the PAU/PMU Main menu

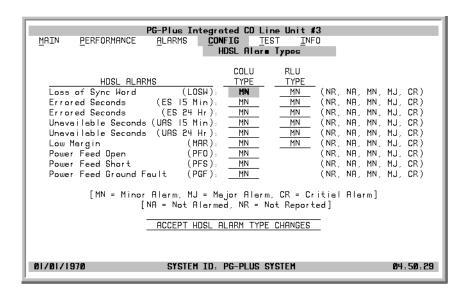
Allows the provisioning of the alarm types for all HDSL Alarms. Table 8 lists the Alarm Reports and Table 9 shows the HDSL Alarms, the possible alarm Types, and the default factory settings. You can view the results of these settings from the "HDSL History Screen" on page 22.

- 3 At the LOSW field in the ICOLU Type column, press **SPACEBAR** to toggle to the desired value, then **TAB** to the RLU Type column.
- When you have completed the changes, move to the Accept HDSL Alarm Type Changes button, and press **ENTER** to accept the changes.
- 5 Press ESC to move up a menu level, or CTRL +R to return to the PAU/PMU Main menu.

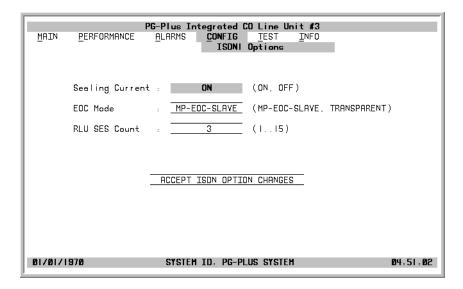
Allows the provisioning of ISDN*n* options: Sealing Current, EOC Mode, and RT SES Count. Table 10 shows the configured system option and the factory default value.

- 3 Highlight the Sealing Current line, press SPACEBAR to toggle to the desired value, then TAB to the next field to be edited.
- When you have completed the changes, press a directional key to move to the Accept ISDNn Option Changes button, and press ENTER to accept the changes.
- 5 Press ESC to move up a menu level, or CTRL +R to return to the PAU/PMU Main menu.

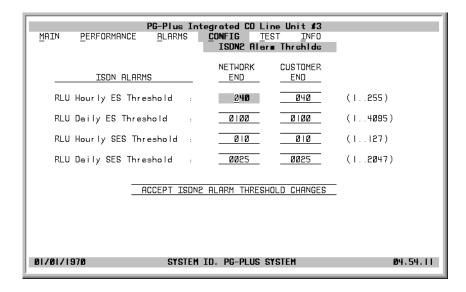
Allows the provisioning of ISDN*n* alarm thresholds. Table 11 shows the configured system option and the factory default value. The fields on this screen are measured hourly and daily.

- 1 Select *CONFIG* from the menu and press **ENTER** to display the submenu.
- 2 Scroll to the ISDNn Alarm Thrshlds option and press ENTER to view the screen:

- 3 Highlight the RLU Hourly ES Threshold line, press **SPACEBAR** to toggle to the desired value, then **TAB** to the next field to be edited.
- When you have completed the changes, press a directional key to move to the Accept ISDNn Alarm Threshold Changes button, and press ENTER to accept the changes.
- 5 Press ESC to move up a menu level, or CTRL + R to return to the PAU/PMU Main menu.

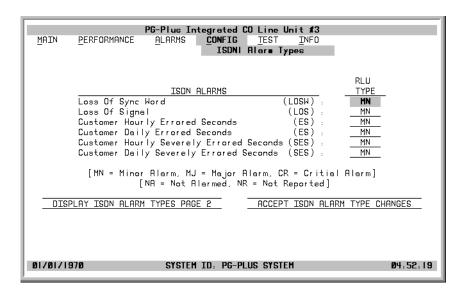
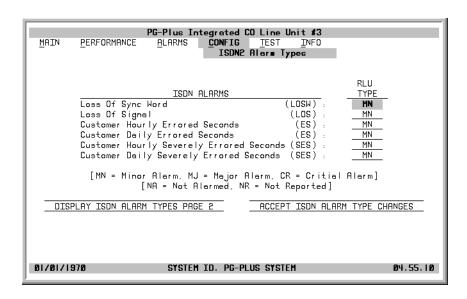
Allows the provisioning of ISDNn alarm types. Table 12 shows the configured system option and the factory default value.

- 1 Select *CONFIG* from the menu and press **ENTER** to display the submenu.
- 2 Scroll to the *ISDNn Alarm Types* option and press **ENTER** to view the screen:

- 3 Highlight the Loss of SYNC Word line, press **SPACEBAR** to toggle to the desired value, then **TAB** to the next field to be edited.
- When you have completed the changes on this page, press the Display ISDN Alarm Types Page 2 button to view the second page of alarms.

- When you have completed the changes, press a directional key to move to the Accept ISDNn Alarm Types Changes button, and press ENTER to accept the changes.
- 6 Press ESC to move up a menu level, or CTRL + R to return to the PAU/PMU Main menu.

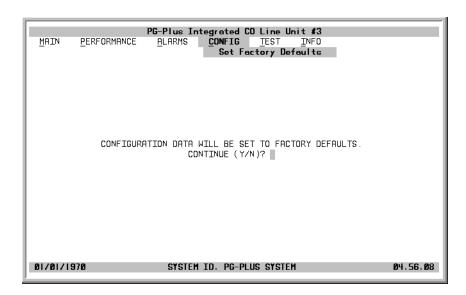
Sets all configuration data back to factory default values.

- 1 Select *CONFIG* from the menu and press **ENTER** to display the submenu.
- 2 Scroll to Set Factory Defaults line and press ENTER to view the screen:

- 3 Type Y at the Continue? prompt to reset the system to the Factory Default values, or N to maintain the current configuration defaults.
- 4 Press ESC to move up a menu level, or CTRL +R to return to the PAU/PMU Main menu.

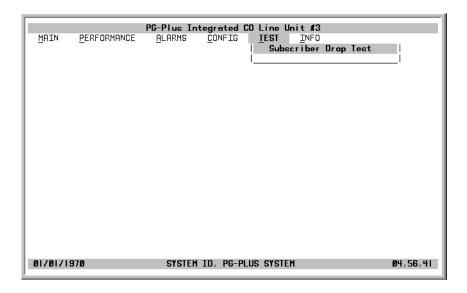
Provides access to SDT tests. Select *Test* at the menu bar and press **ENTER** to display the submenu.

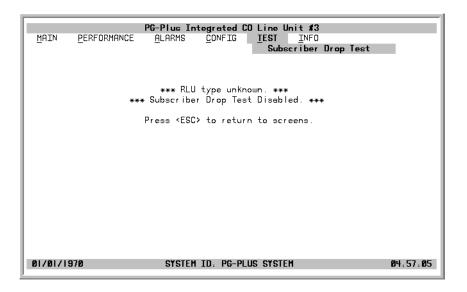
Subscriber Drop Test Screen

PG-Plus supports testing of a subscriber drop in two ways. A test can be initiated by applying a test voltage between the Tip and Ring at the ICOLU through an MLT test set or by selecting it from the menu item through the VT-100 terminal connected to the PAU Craft port. The relays in the ICOLU and RT provide a path for performing a SDT.

1 Scroll to the Subscriber Drop Test option and press ENTER to view the results of the test:

- 2 Go to the Test option, and select the desired circuit to test.
 - 3 View the SDT results. Refer to the Test Submenu section for specific results.
 - 4 At the RT, check for ringing at the RT with the RJ-11 test jack open. If ringing is not present, check for ringing on another line terminated on the same RT. If ringing is present on other lines, check for high-resistance shorts on the subscriber drop. If no high resistance shorts, replace the RT.

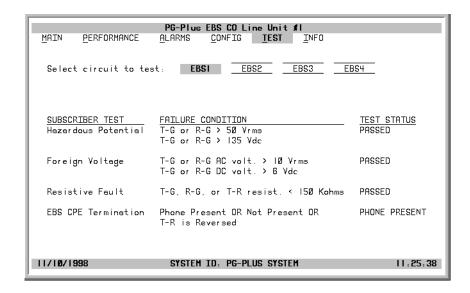
When the tests are complete, the Drop Tests Results screen displays. The results contains Subscriber Test, Failure Condition, and Test Status. Tests are performed in the order of display. If a test fails, the remaining tests are not performed (as per TR-909). It takes approximately 7 to 8 seconds for all tests to complete.

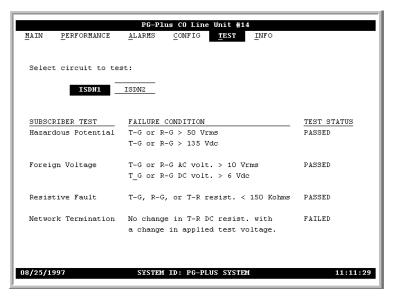
If you have ISDN services supported, then the following screen displays:

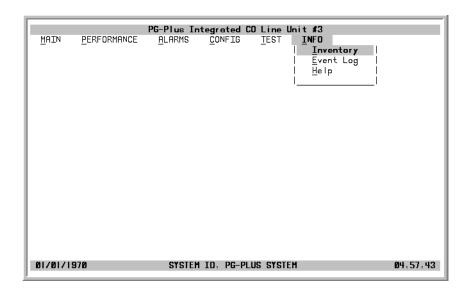
Provides technical information about the ICOLU and contact information for PairGain Technologies, Inc.

1 Select *INFO* from the menu and press **ENTER** to display the submenu.

- 2 Select either *Inventory*, *Event Log*, or *Help* to view the associated screen.
- 3 Press ESC to move up a menu level, or CTRL + R to return to the PAU/PMU Main menu.

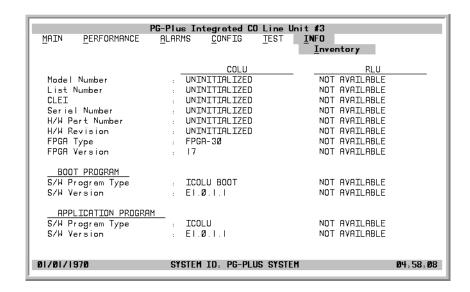
Inventory Screen

Displays all the critical information about the ICOLU and RT. Press **ESC** to move up a menu level, or **CTRL** + **R** to return to the Main menu.

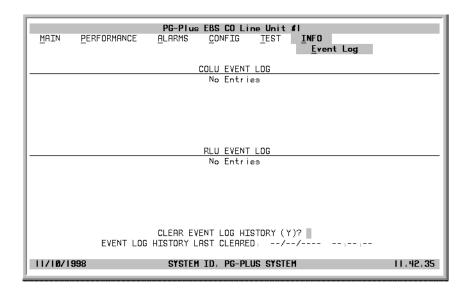
Event Log Screen

The Event Log screen provides information events that occurred but that are not Alarmed events. The two Events logged are as follows:

- MEMVER A provisioning database conversion occurred when a software download occurred. MEMVER
 is informational only. Event is cleared if you reseat the ICOLU, however it is not required. No
 customer action is required.
- MEMCHK The provisioning factory defaults were restored due to a corrupted database. MEMCHK is
 informational only. To clear the MEMCHK alarm, at the CONFIG submenu option Set Factory
 Defaults, type Y at the Accept the Set Factory Defaults prompt. No customer action is required.

- 1 Type Y at the Clear Event Log History? prompt to clear the information. The date and time the Event Log History was last cleared displays.
- 2 Press Esc to move up a menu level, or CTRL +R to return to the PAU/PMU Main menu.

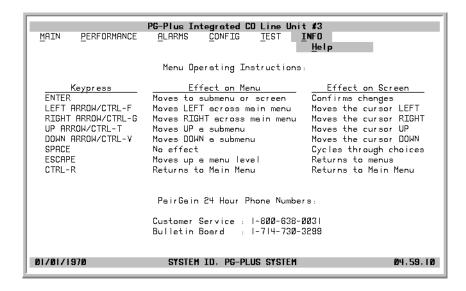
Help Screen

Provides information on using the ICOLU screens and menus. The Help screen also lists the PairGain Customer Support and Bulletin Board telephone numbers. Press **ESC** to move up a menu level, or **CTRL** + **R** to return to the Main menu.
