PG-PLUS

TECHNICAL PRACTICE

ISDN CENTRAL OFFICE LINE UNIT

Model	List	CLEI Code
PLL-723	1	S9L1AD0A~~

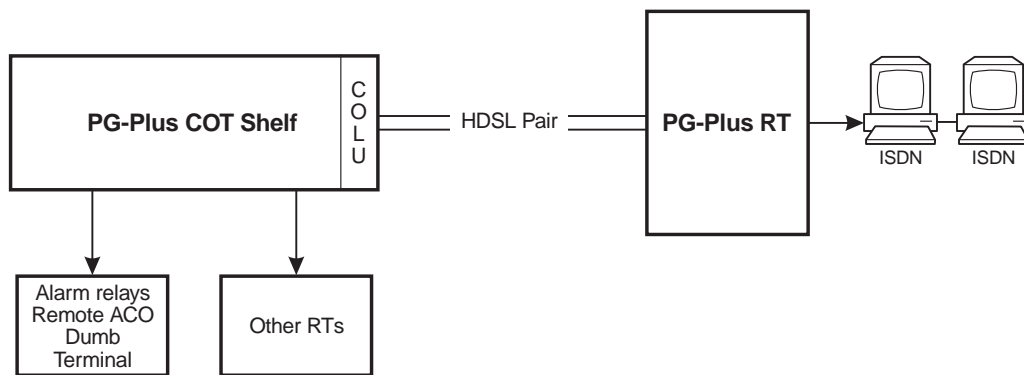
Figure 1. Typical System Application

A PG-Plus application, consisting of one COTS, one COLU and one RT, (see [Figure 1](#)) provides bidirectional transport of multiple DS0 over a single, unconditioned wire pair using HDSL technology. Using existing cable, PG-Plus provides for higher bandwidth needs of residential and business customers by providing three POTS and an ISDN interface on a single HDSL twisted-pair wire.

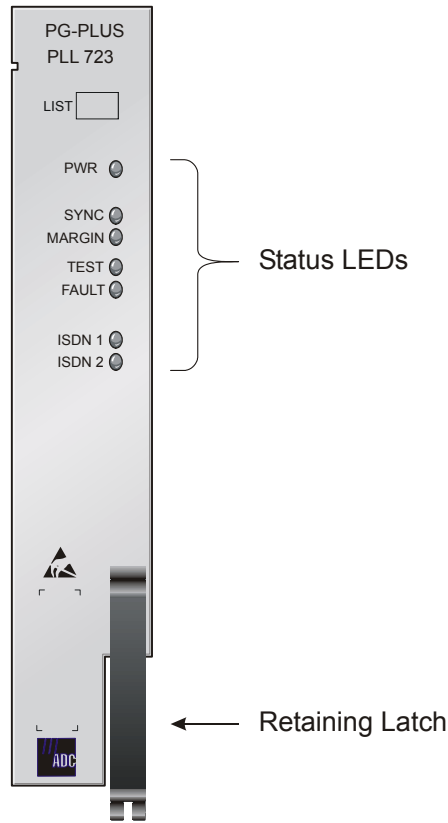
Figure 2. COLU Front Panel LEDs

Table 2, in which n equals the POTS line, describes the COLU front-panel LEDs depicted in Figure 2. For further details on the LEDs activities, refer to “Initialization Sequence” on page 8 and the “COLU and RT Fault Indicators” on page 39.

LEDs	Condition	Mode
PWR	On	COLU is powered and the dc power provided to the HDSL pair is normal
	Flashing	One battery feed is missing or a battery feed fuse on the COLU is blown
	and FAULT Flashing	The dc power provided to the HDSL pair is out of normal range
	On, all others flashing at 1 Hz	Running in Boot Mode due to invalid Application Program
	On, all ISDN LEDS On, all others running downward at 1 Hz	Active software download of the COLU
	On, all ISDN LEDS On, all others running upward at 1 Hz	Active software download of the RT connected to the COLU
SYNC	On	HDSL is in synchronization between COLU and RT
	Flashing	COLU and RT are attempting to synchronize
MARGIN	On	COLU HDSL margin is equal to or below the threshold value.
	Flashing	RT HDSL margin is equal to or below the threshold value.
TEST	and ISDN n Flashing	SDT is occurring on ISDN n or loopback is active on ISDN n .
FAULT	On	COLU has a fault.

Flashing	Alarm condition exists on the COLU.
ISDN n	On	Channel is active and ready for layer 2 communication.

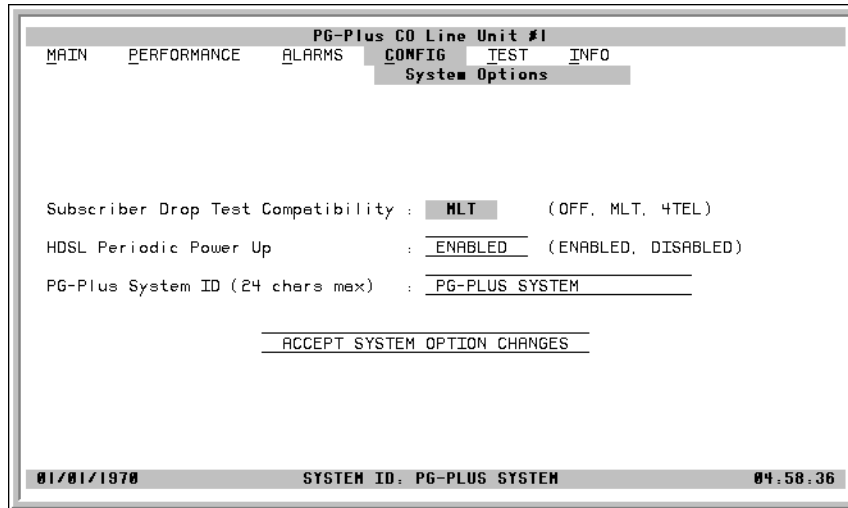
System Options Screen

Allows the provisioning of options such as ringing frequency, SDT, HDSL Periodic Power Up, and a System ID. Table 6 shows the configured system data and their factory default value.

- 1 Select *CONFIG* at the menu bar and press **ENTER** to display the submenu.
- 2 Scroll to the *System Options* line and press **ENTER** to view the screen:

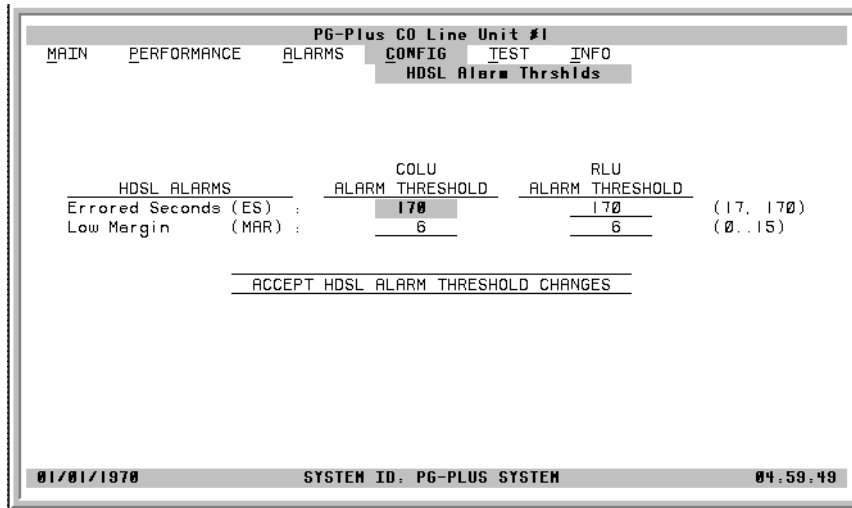
This screen is a means to provision the threshold crossing values for the 15 minute and 24-hour ES and UAS counts and low margin dB. Table 8 lists the fields of the HDSL Alarm Thresholds and the default factory values.

- 1 Select *CONFIG* at the menu bar and press **ENTER** to display the submenu.
- 2 Scroll to the *HDSL Alarm Thrshlds* option and press **ENTER** to view the screen:

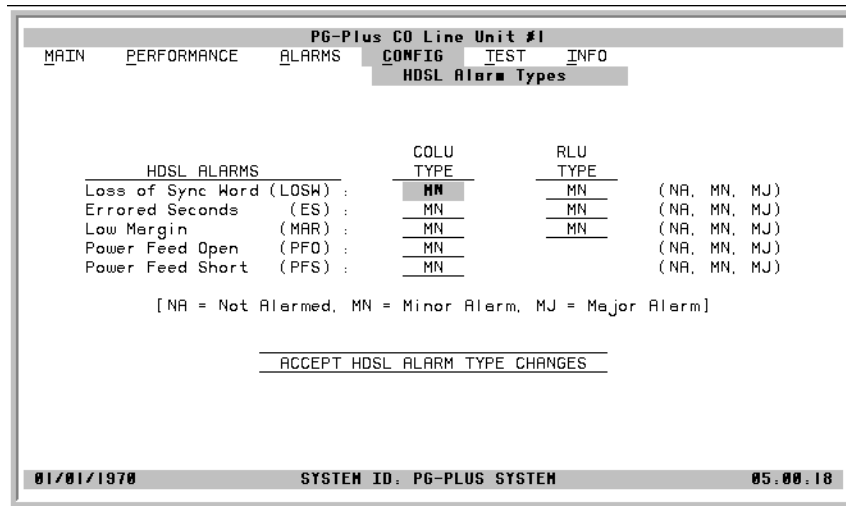
Allows the provisioning of the alarm types for all HDSL Alarms. [Table 9](#) lists the Alarm Reports and [Table 10](#) shows the HDSL Alarms, the possible alarm Types, and the default factory settings. You can view the results of these settings from the “HDSL History Screen” on page 22.

- 1 Select *CONFIG* at the menu bar and press **ENTER** to display the submenu.
- 2 Scroll to the *HDSL Alarm Types* option and press **ENTER** to view the screen:

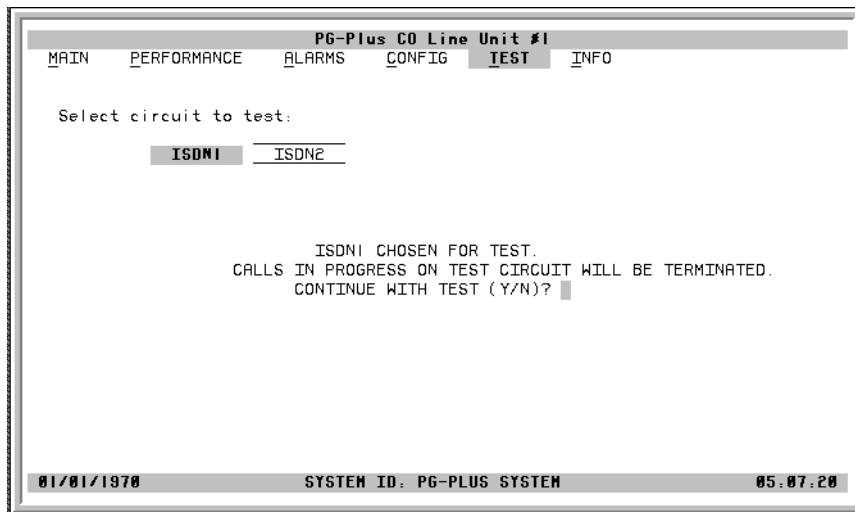
PG-Plus supports testing of a subscriber drop in two ways. A test can be initiated by applying a test voltage between the Tip and Ring at the COLU through an MLT test set, or by selecting it from the menu item through the VT-100 terminal connected to the PAU/PMU maintenance port. The relays in the COLU and RT provide a path for performing a SDT.

- 1 Select *Test* at the menu bar and press **ENTER** to display the submenu.
- 2 Scroll to the desired *ISDNn* option and press **ENTER** to start the test:

- 4 A warning displays when a channel is selected for the test.
