PG-Flex^{Plus} 24 Channel Central Office Line Unit – Quick Installation Guide

OVERVIEW

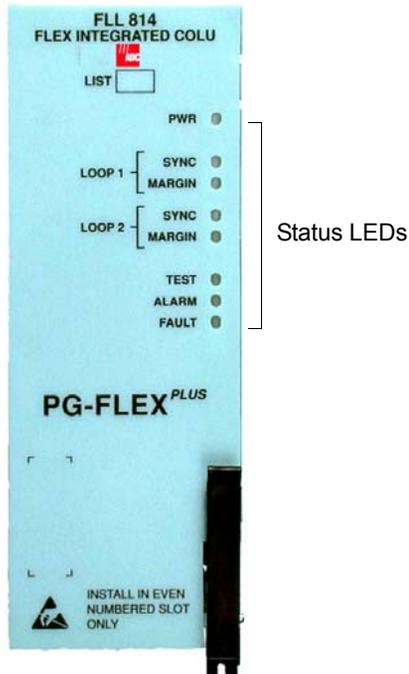
Figure 1. FLL-814 Front Panel

Figure 1 shows the FLL-814 front panel.

Table 2 lists the front panel LED indications for the FLL-814.
